EMBANKMENT CRITERIA AND PERFORMANCE REPORT

SALT CREEK AND TRIBUTARIES, NEBRASKA

SITE 10

YANKEE HILL DAM AND LAKE

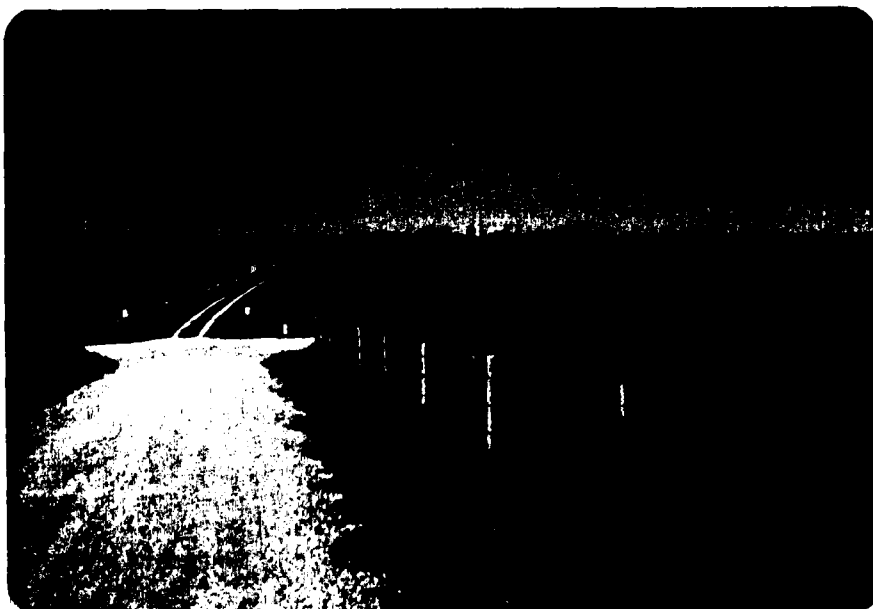
Photo No. 7 - View of embankment crest road, gage house, intake structure, and downstream slope from the southeastern end of the embankment. Normal Pool Conditions.
